**Total Land Subsidence in the Fort Grant Rd and Willcox Areas, Cochise County
Based on Radarsat-2 Satellite Interferometric Synthetic Aperture Radar (InSAR) Data**

Time Period of Analysis: 1.9 Years 04/30/2011 To 03/26/2013

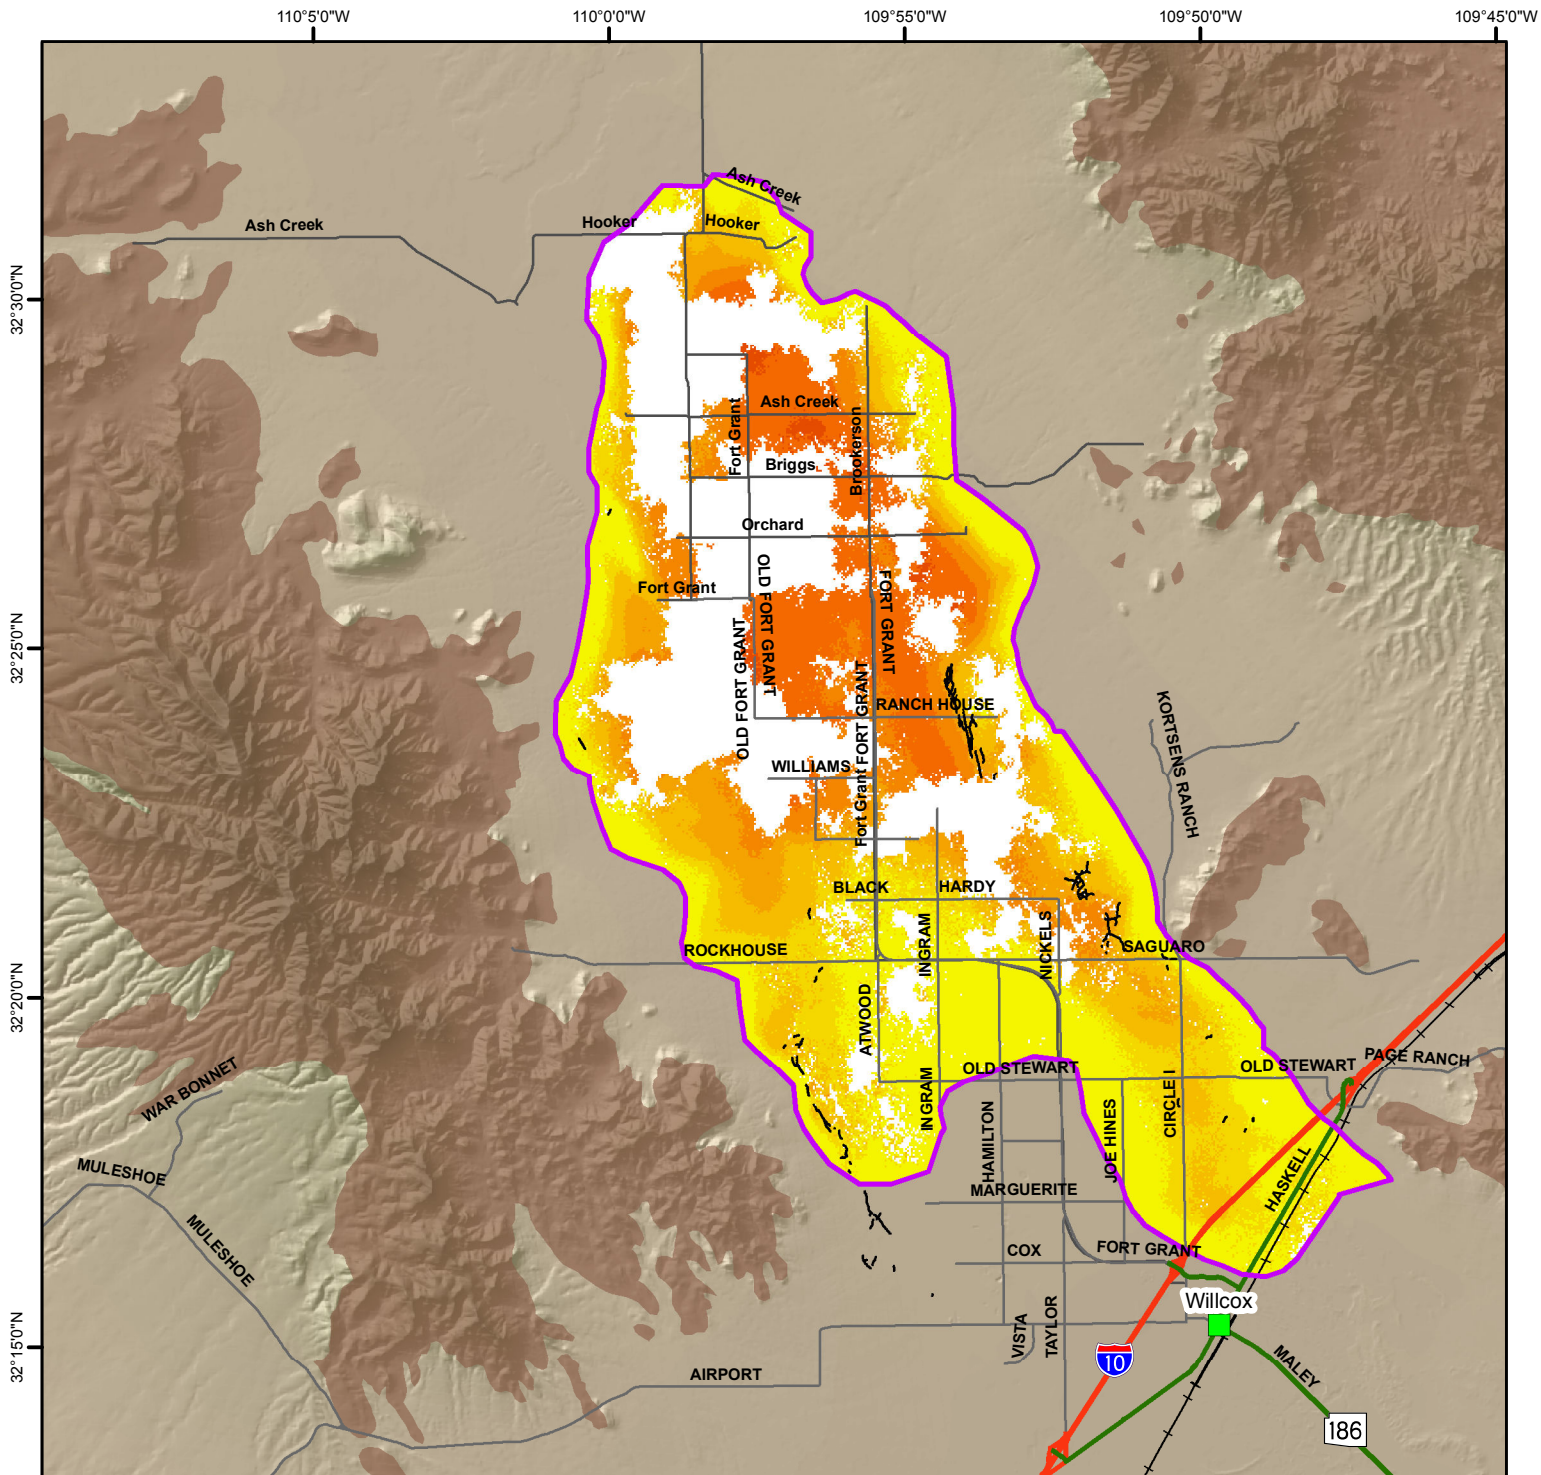
Decorrelation (white areas) are areas where the phase of the received satellite signal changed between satellite passes, causing the data to be unusable. This occurs in areas where the land surface has been disturbed (i.e. bodies of water, snow, agriculture areas, areas of development, etc).

Earth fissures were mapped by the Arizona Geological Survey.
For information on earth fissures visit: www.azgs.gov/EFC
